# FROM THE SHOP FLOOR

## 12-VALVE DOWEL PIN COMMON-SENSICAL SOLUTION

## The TST Solution

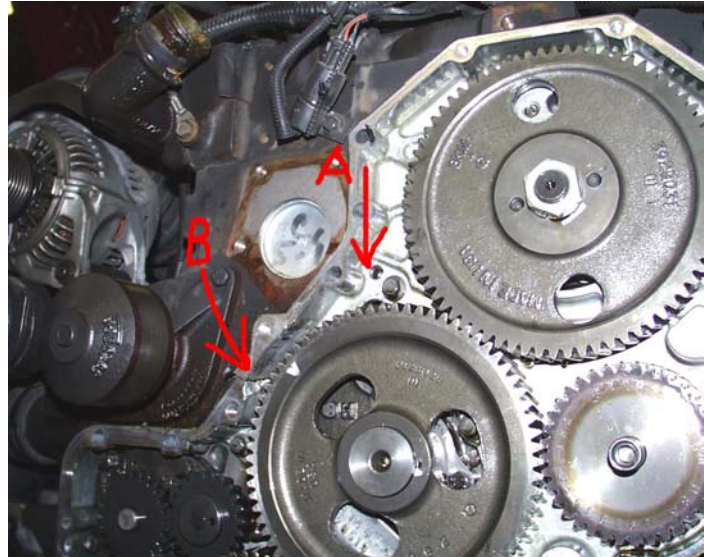
The belief is that the vibrations and weight of the P7100 fuel pump cause the dowel pin to loosen in its bore and possibly fall out. If the dowel pin does fall, it can be caught in the fuel pump gear causing a major problem (cracked cam nose); or it can fall between the cam gear and the front housing and, in its path to the bottom of the oil pan, crack the gear case housing. I've heard many a story of how the cracked housing has been fixed using J-B Weld epoxy. Alternately, the gear housing can be removed and replaced, but this is a big task as the engine's camshaft has to be removed to remove/replace the housing. A final fall-out scenario, the pin falls to the bottom of the oil pan and resides in the bottom of the pan forever (or at least until the pan is removed). There is a screen on the oil pickup tube that prevents the pin from moving into anywhere other than the bottom of the oil pan.

For those not familiar with the dowel pin the arrow shows its location.

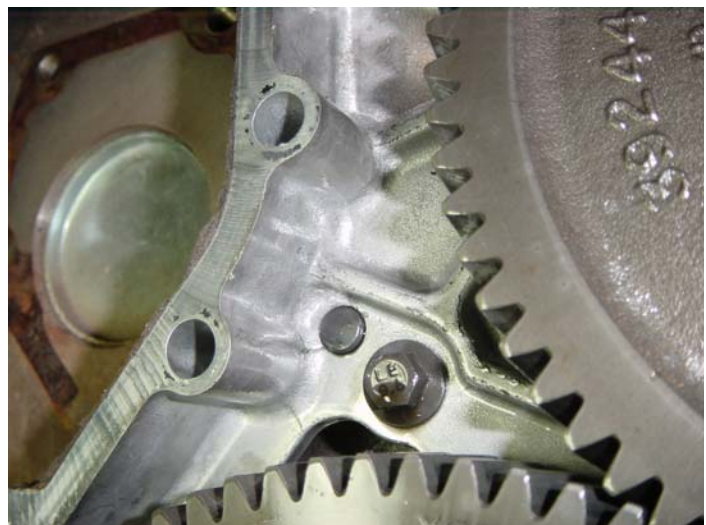
A close-up picture of the dowel pin.

- 12) Locate the dowel pin and look to see if it is fully seated. Most of the pins will be flush with the gear housing or just below flush if they have not backed out. If the pin seems to be backed out find a small punch. With a hammer and punch tap on the head of the dowel pin and drive it into the block as far as possible.

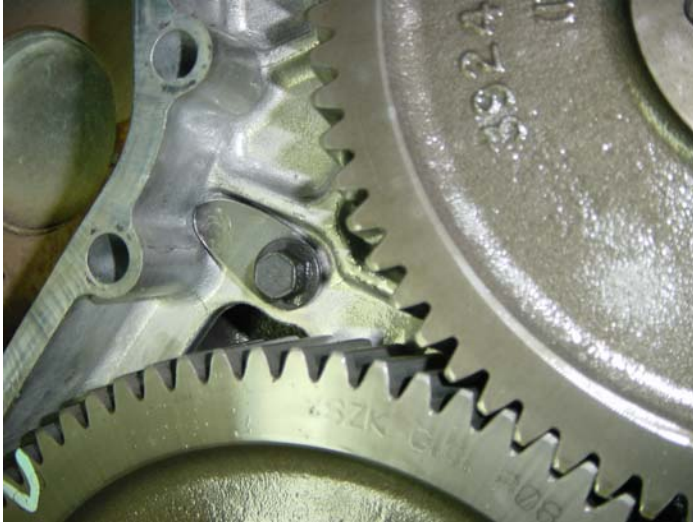
Above is a picture of an egg-shaped washer that is their solution to the problem.

- 13) Lucky step 13! Time to install the special egg-washer, preventive maintenance part. Locate the 10mm bolt next to the dowel pin and remove it, reinstall the longer bolt using the special washer supplied in the kit. This washer will prevent the dowel pin from backing out. Apply loctite high strength (red) thread locker to the threads and torque the bolt to 18 ft. lbs. torque.
