# FROM THE SHOP FLOOR

## 12-VALVE DOWEL PIN COMMON-SENSICAL SOLUTION

## The TST Solution

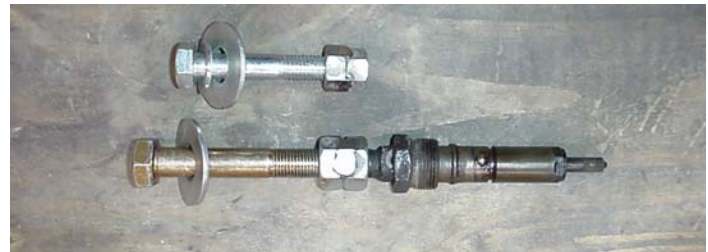
This is an innovative shop tool developed by TST to remove 12-valve injectors.

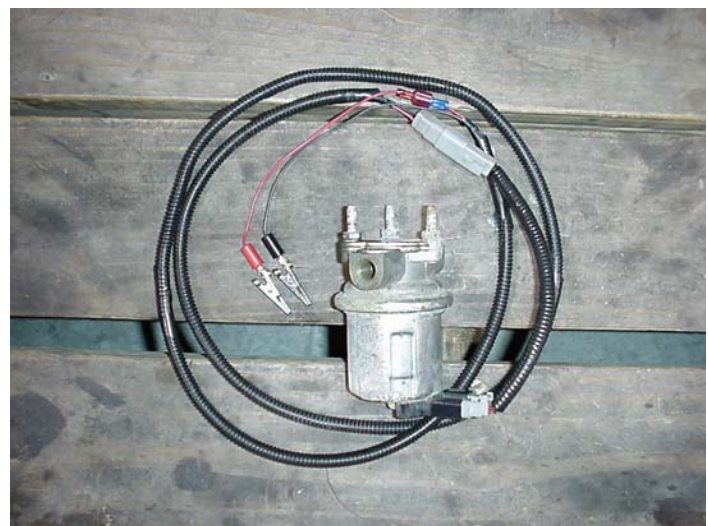
Another shop trick: testing a 24-valve fuel delivery pump is easy with the correct wiring harness and jumper leads that go directly to a 12-volt battery.
